## Dental Implant Restorations

### The problem of cement

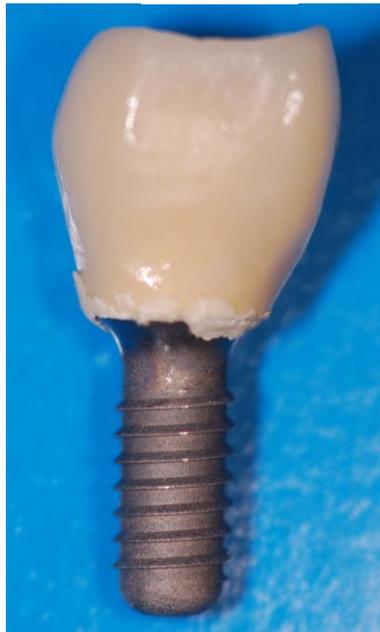
Fig. 2

Peri-implant bone loss (A) from excess subgingival cement (B) with loss of implant integration.

Today, about 75% of dental implant restorations are cement retained. Incomplete removal of cement from the sulcular peri-implant tissues leaves a nidus of inflammation that causes bone loss that can lead to loss of osseointegration. The thin junctional epithelium around a dental implant is not a good barrier against the hydraulic pressure placed on it from apically extruding cement secondary to forces applied during cementation of an implant restoration. Excess cement that coats a roughened implant surface is also near impossible to remove completely and will damage a successful integrated implant.

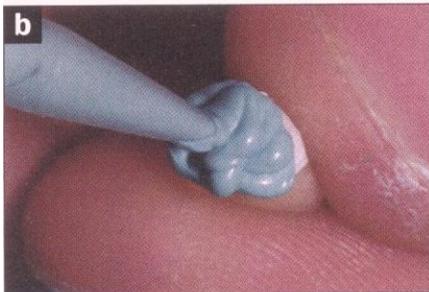
**Figure 5b.** The inside of the polytetrafluoroethylene crown is filled with a fast setting material (eg, Blu-Mousse [Parkell]).

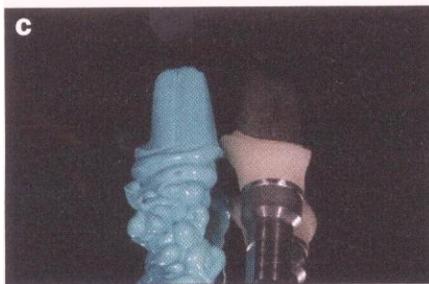
**Figure 5c.** When the copy abutment is removed, it is compared to the original abutment, and orientation is noted.

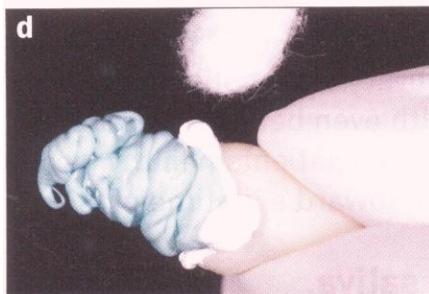
**Figure 5d.** The crown loaded with cement has the copy abutment seated into it. This allows for the cleanup to be primarily done outside the mouth.
